The Ching Action Plan

Hertfordshire and North London

Date: September 2024

Version: 4.0

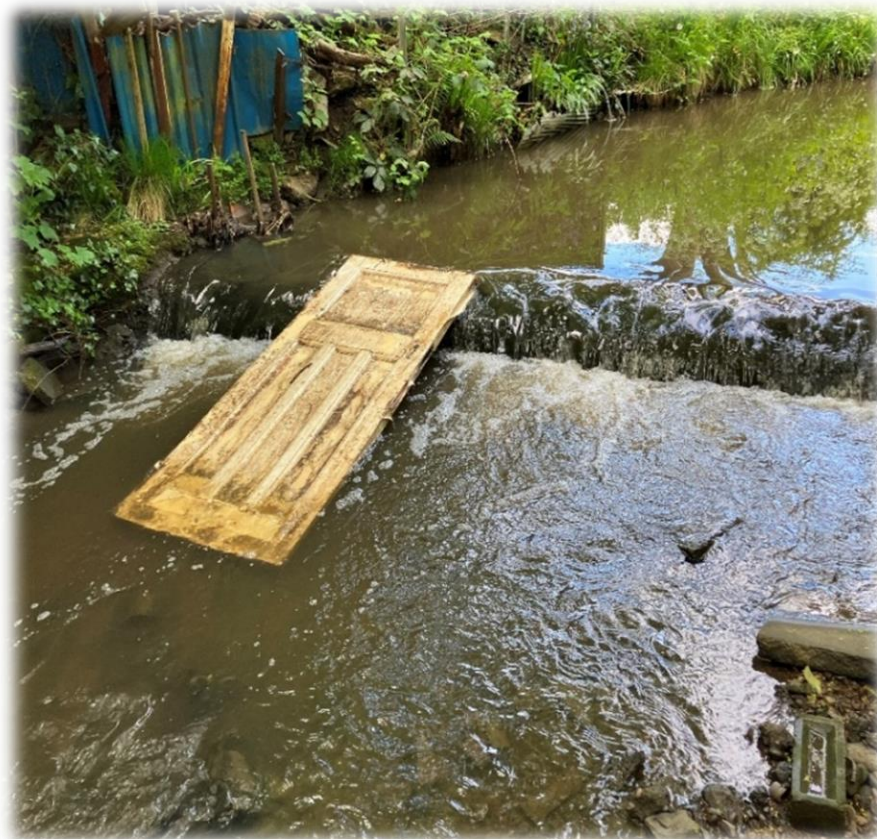
The Ching at the Studley Avenue weir

12	Habitat and channel restoration near Winchester Road	Fish Invertebrates M&P Physico-chemical Mitigation Measures	2	TQ3838591401 magic.plates.items	33197
13	Improve fish passage over Studley Avenue Weir	Fish Mitigation Measures	2	TQ3865091435 speak.hood.jump	33201
14	Improve fish passage over Falmouth Avenue Weir	Fish Mitigation Measures	2	TQ3921891935 delay.radio.singer	33199
15	Improve fish passage in channel at Waterhall Avenue	Fish Mitigation Measures	2	TQ3916392721 cargo.hiking.golf	33206

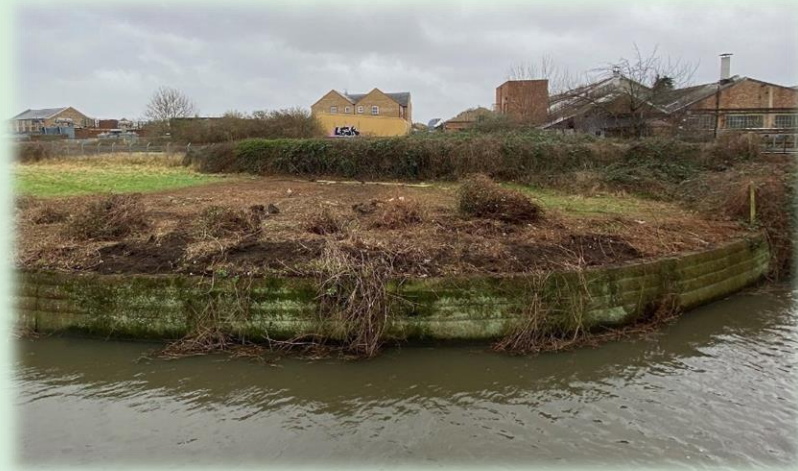
The photos on this page are an example from the river Crane where a previously lifeless concrete channel was successfully transformed into a thriving space.

River Crane site before restoration. Credit: ©Wild Future

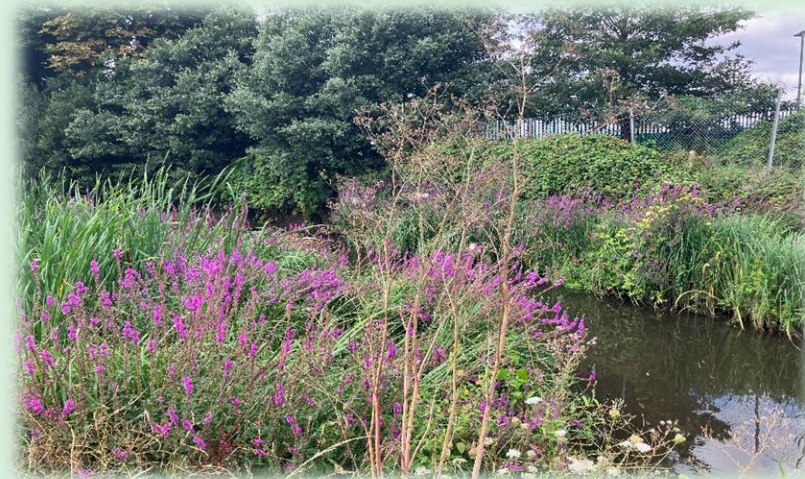
River Crane site after restoration. Credit: Lewis Elmes

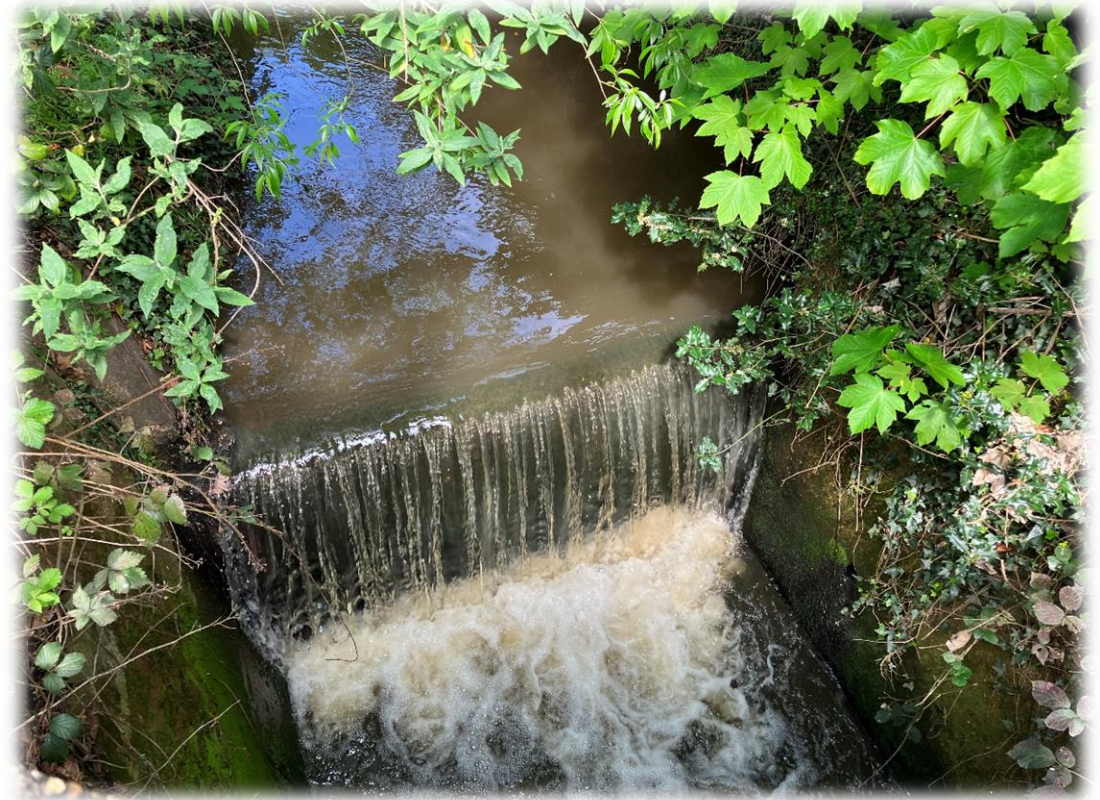
The Ching at the Falmouth Avenue weir

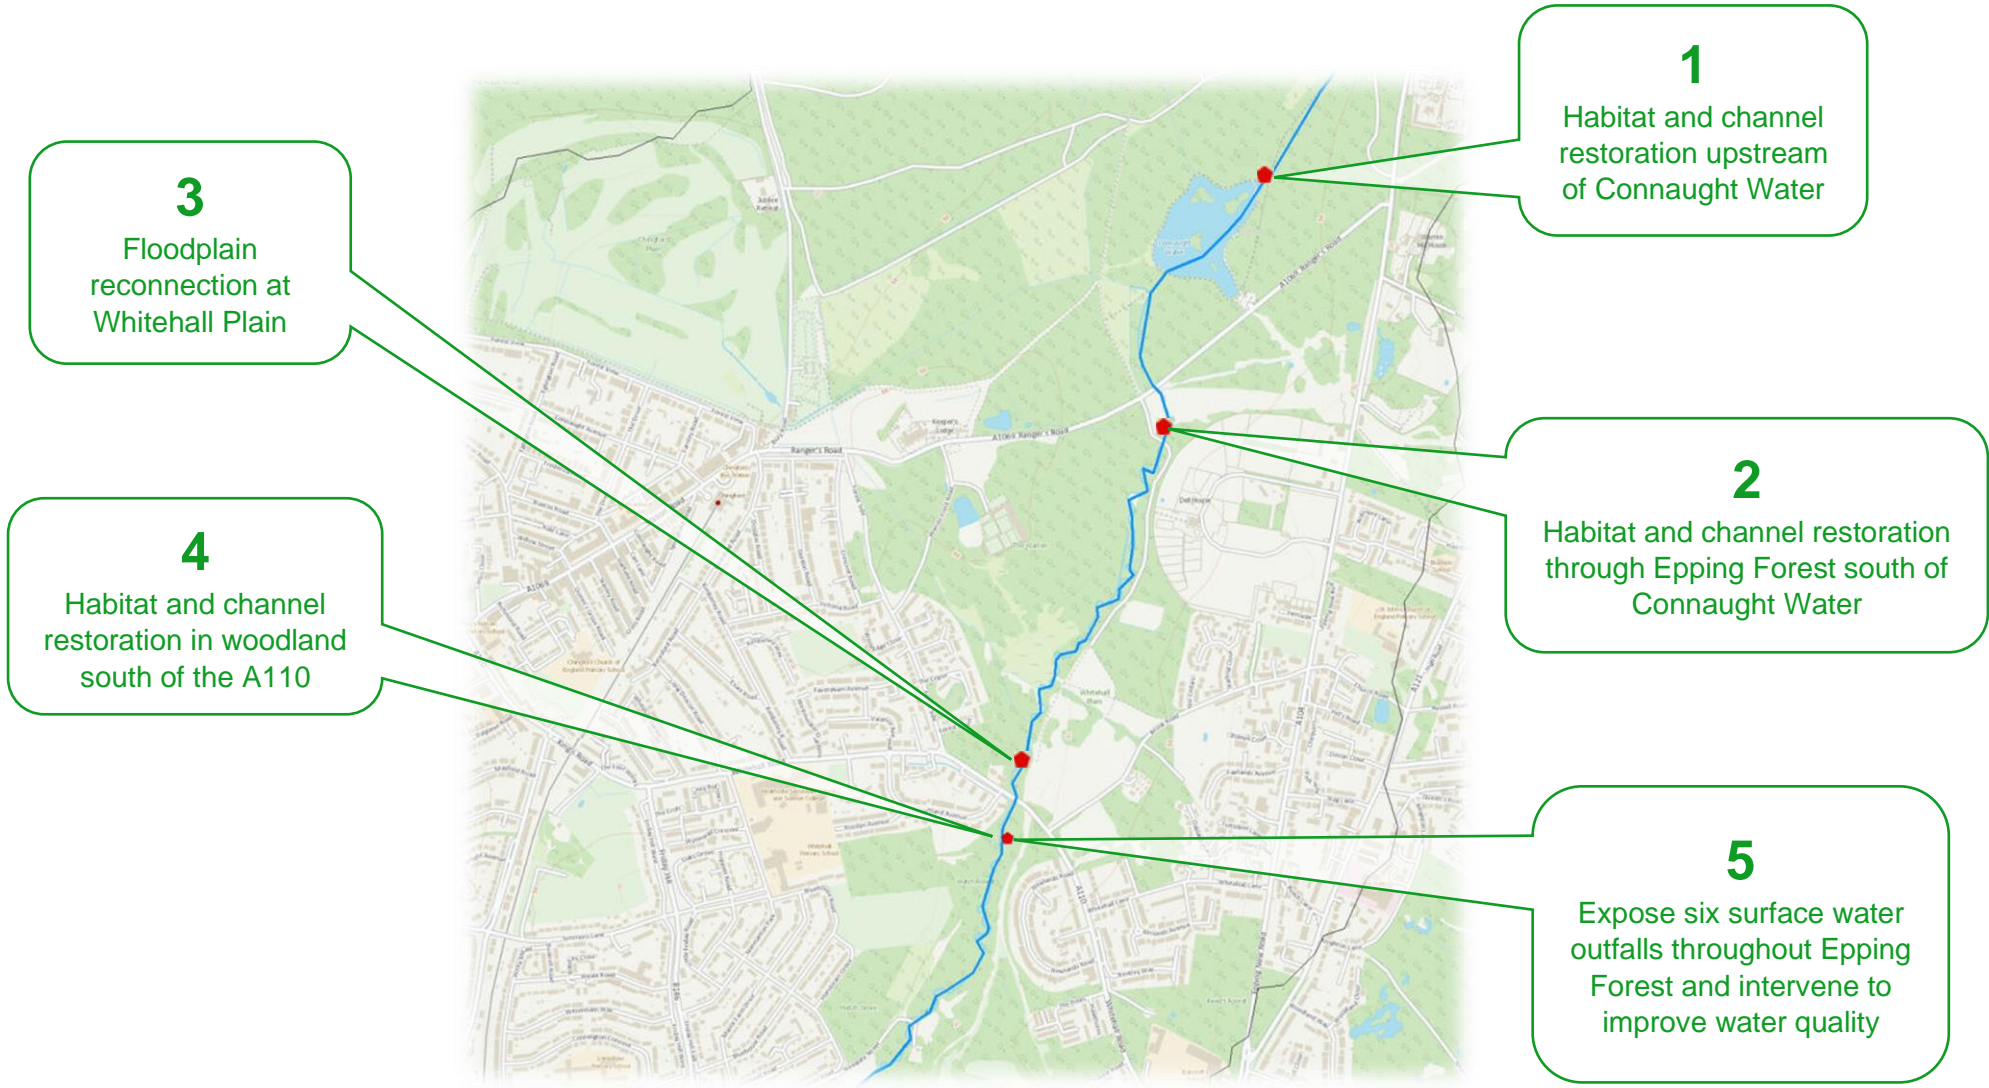
Restoration Reach 1 – Epping Forest

Map Number	Project Title	WFD Elements Improved	Restoration Reach	Approximate Grid Reference & What3Words	CPS Action Number
1	Habitat and channel restoration upstream of Connaught Water	Invertebrates M&P* Physico-chemical Mitigation Measures**	1	TQ4046895438 eggs.raves.activism	TBC
2	Habitat and channel restoration through Epping Forest south of Connaught Water	Invertebrates M&P Physico-chemical	1	TQ402948 props.export.shower	TBC
3	Floodplain reconnection at Whitehall Plain	Invertebrates M&P Mitigation Measures	1	TQ399940 grades.supply.cakes	TBC
4	Habitat and channel restoration in woodland south of the A110	Invertebrates M&P Physico-chemical Mitigation Measures	1	TQ399938 brings.elite.violin	TBC
5	Expose six surface water outfalls throughout Epping Forest and intervene to improve water quality	Physico-chemical	1	TQ399938 brings.elite.violin	TBC

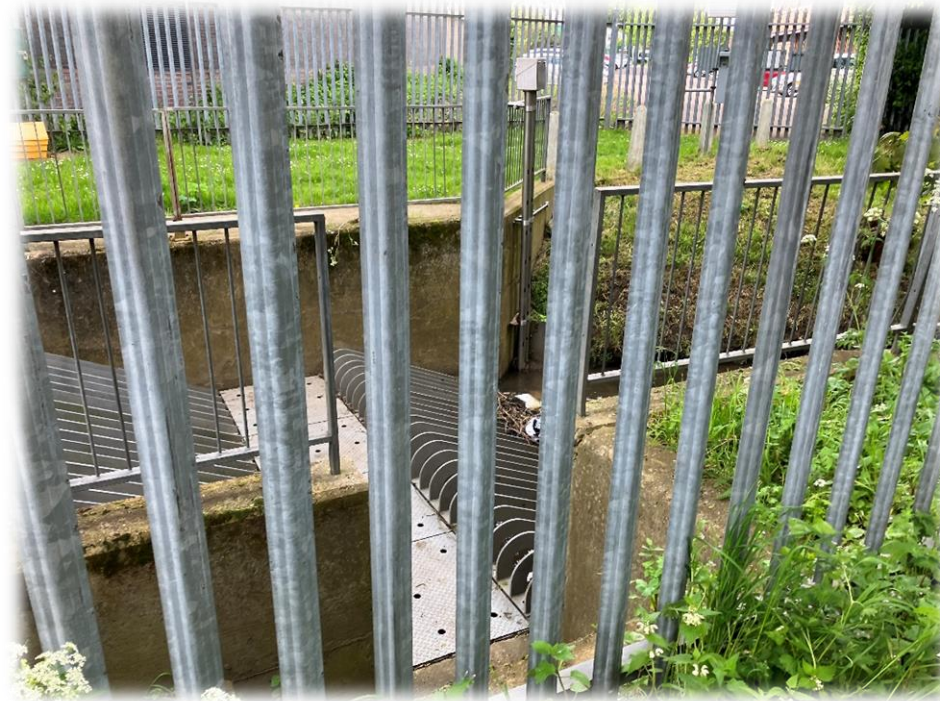
The beginning of the culvert at the Arsenal Youth Training Ground

The Environment Agency maintain two assets along the Ching. The first is the Ching Brook trash screen at the start of the culvert adjacent to the Arsenal Youth Football Academy, and the second is St Leonard's School Weir at the start of the culvert at Chingford Hall Primary School.
